MEYLE No. 300 333 1111/HD
Reference No. 33 31 1 094 036

Subframe mount

BMW E39

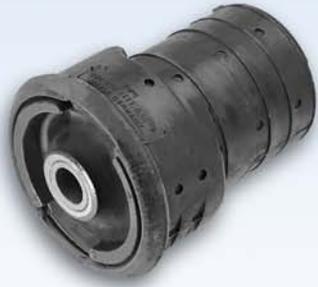
Leakage of hydro fluid due to high dynamic strain and small bonding surface

- Rattling from the rear axle and an overall decline of the handling of the vehicle
- Reduced driving comfort

Hydro mount replaced by an optimised full-rubber mount with a larger bonding surface

No leakage possible and significant longer lifetime without restriction of driving comfort
